Thermal Inspection sample

Executive Home Inspections

2013-12-26

Sample Client
Sample Drive
Salt Lake City, Utah
Sunny 25 degrees - snow cover

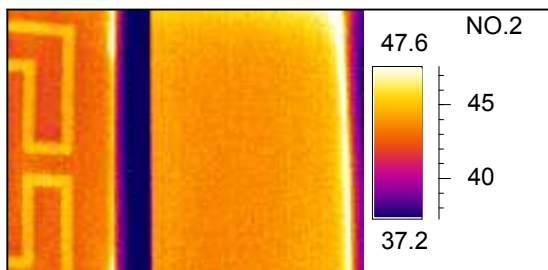
Efficiency of the stained glass windows by the front door is minimal.

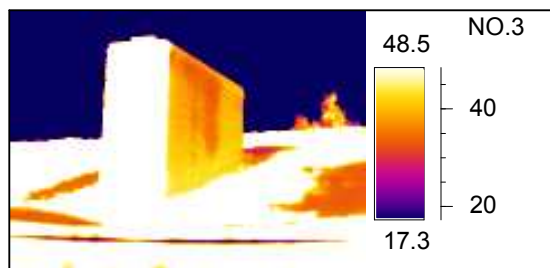
Chimney shows air voids after Level/span was adjusted from the very cold temperature of the sky.

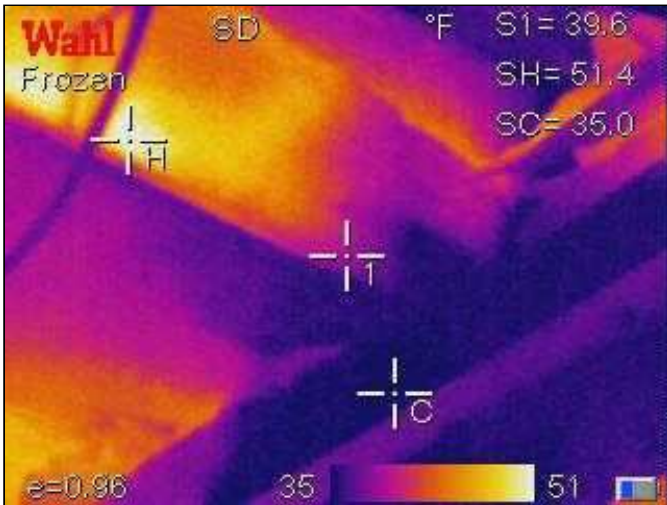
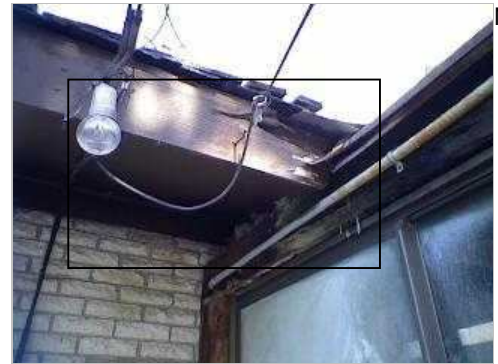
Water damage at the soffit area above the main disconnect.

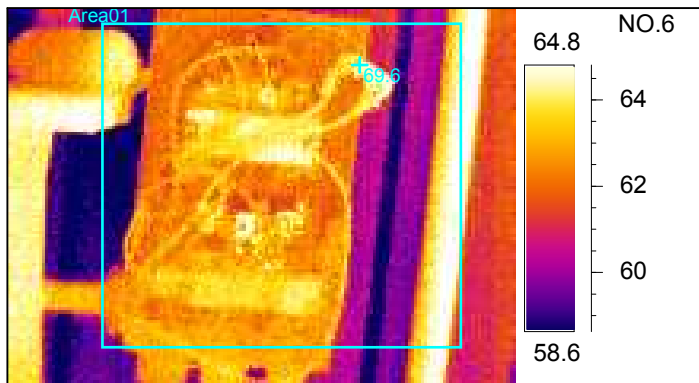
NO.6

View of pool timer relay. Triple taps noted the switch area suggesting loose connection. Professional repairs needed.

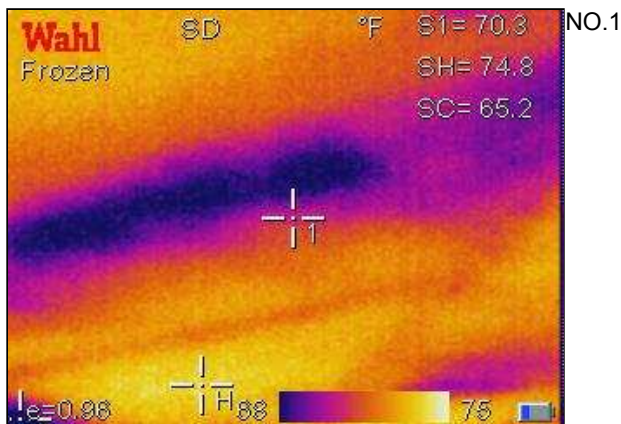
Insulation missing or compressed at the center area of the master bedroom.

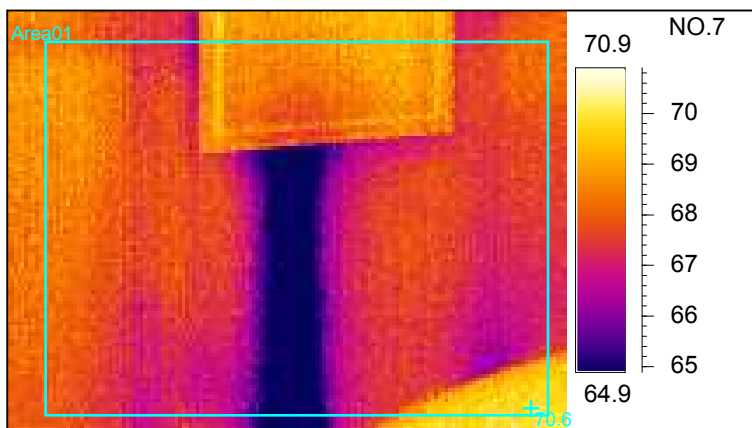
NO.7

Insulation missing on the wall in the upstairs family room. This area may have been an interior wall at one time.

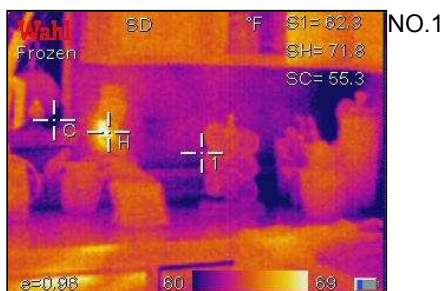
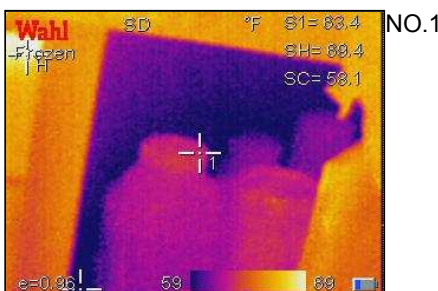
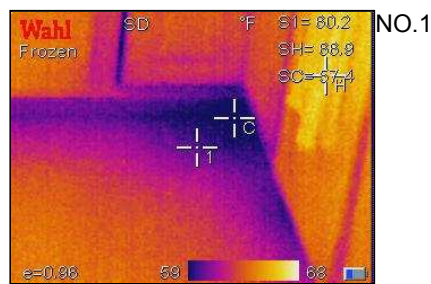
Above three photos show very cold temperatures on the kitchen east wall, including behind the cabinets and at the floor to cabinet area. These areas are much cooler than other interior walls of the home. Would suspect this area is not insulated. Corrections may not be possible without significant modifications to the cabinets etc. Update if desired.

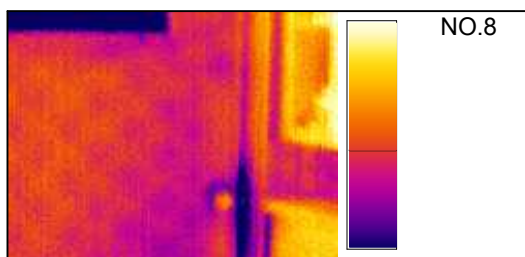
NO.8

Crate patterns in the kitchen exterior door suggest that this door is not a solid wood door. Updates recommended.

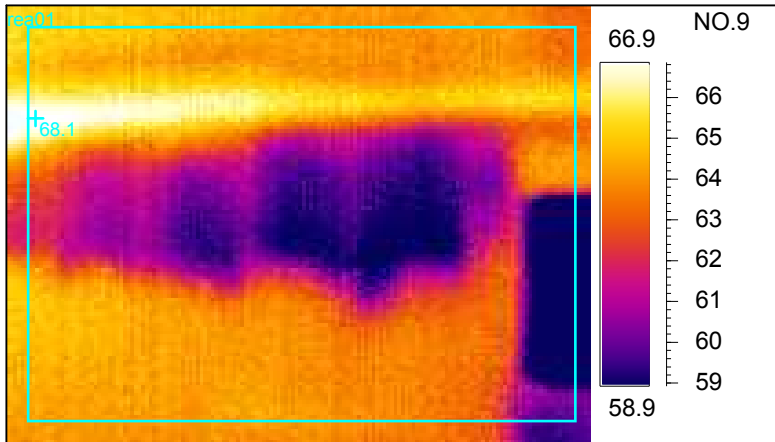
NO.9

Insulation settled in the walls of the basement at all finished rooms. Cold spots noted at the ceiling areas. 18 degree difference noted.

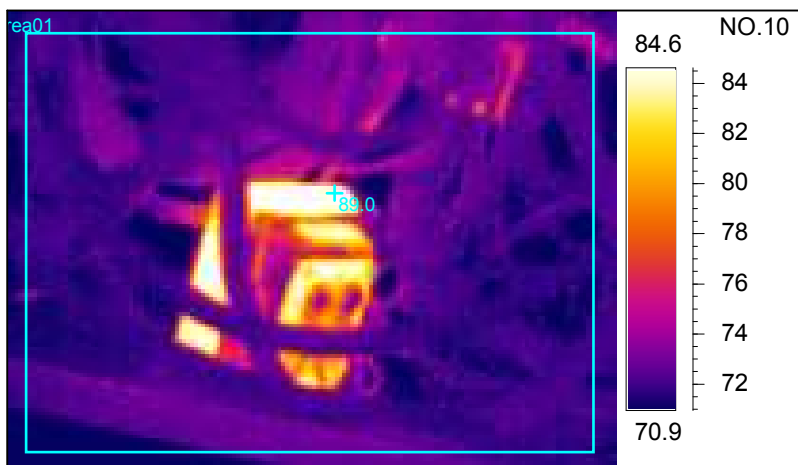
NO.10

Low voltage door bell relay inside the main panel in the basement. Relay should be located outside the panel. Relocate as needed. Repairs should be performed by a licensed electrician.
